5 SCENARIOS FOR DEALING WITH THE FAILED DAM ON PINE LAKE

Scenario 1: *Status quo*, riverside meadow

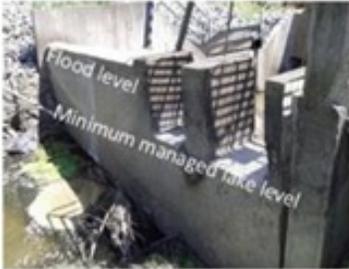
<p>Failure #1: Erosion leading to leakage under the northern base of the dam</p>

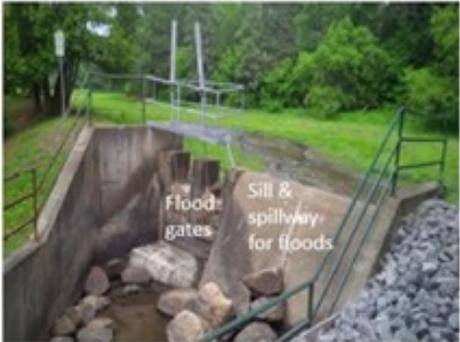
<p>Failure #2: Separation of dam from southern side wall, rotational shift of the dam wall structure</p>	<p>SCENARIO 5 Build earthen dike -- restore lake, less flood control</p>
		<p>SCENARIO 6 Dam & diversion of Black Creek -- restore lake with improved flood control</p>

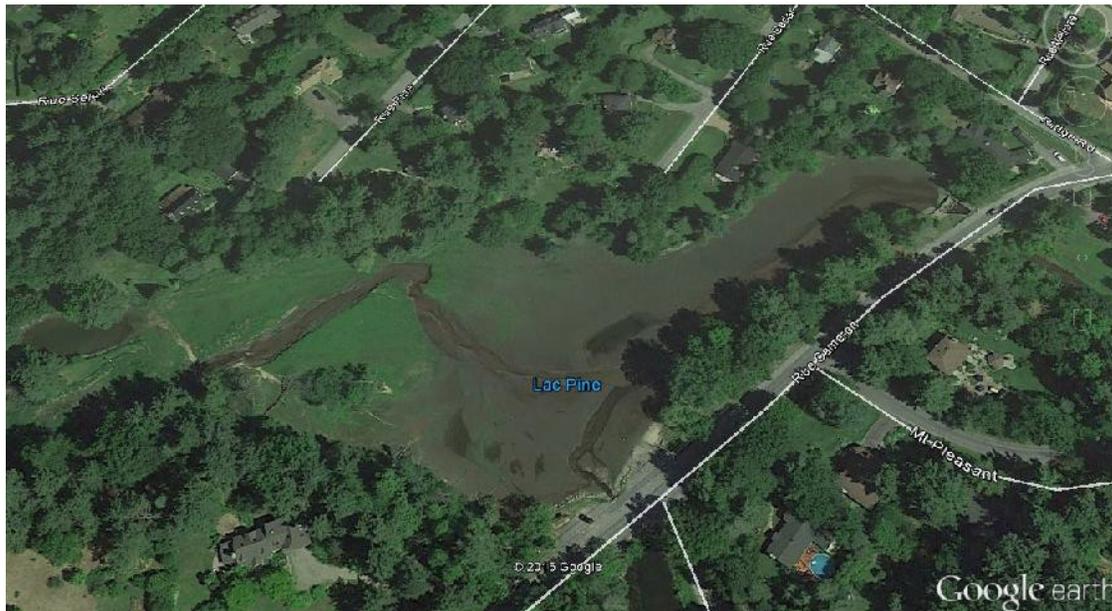
Figure 1. Pine Lake basin on 18 June 2014, two months after the dam failed. During summer 2014 the lake bed was colonized by meadow grasses and wildflowers, which persisted in 2015. The damaged dam is in place, and flood waters have partially and temporarily refilled the lake basin during intense rainstorms in 2014 and 2015.

Note that the Viviry River flows through the drained lakebed and a major tributary (Black Creek) flows under Cameron Road into the lake basin to join the Viviry just upstream of the present dam site. This is noteworthy because the Black Creek sub-basin accounts for 30% of the Viviry River watershed, which significantly increases the amount of floodwater reaching the present dam site. In consideration of ongoing climate change this is worrisome in that only 27% of the Black Creek drainage basin is in Hudson -- we do not control land development in the other 73% of the sub-basin that lies in St-Lazare and Vaudreuil-Dorion. Runoff and sedimentation into Black Creek will increase as land is developed in the sub-basin. Hence flood risk is likely to increase in future.

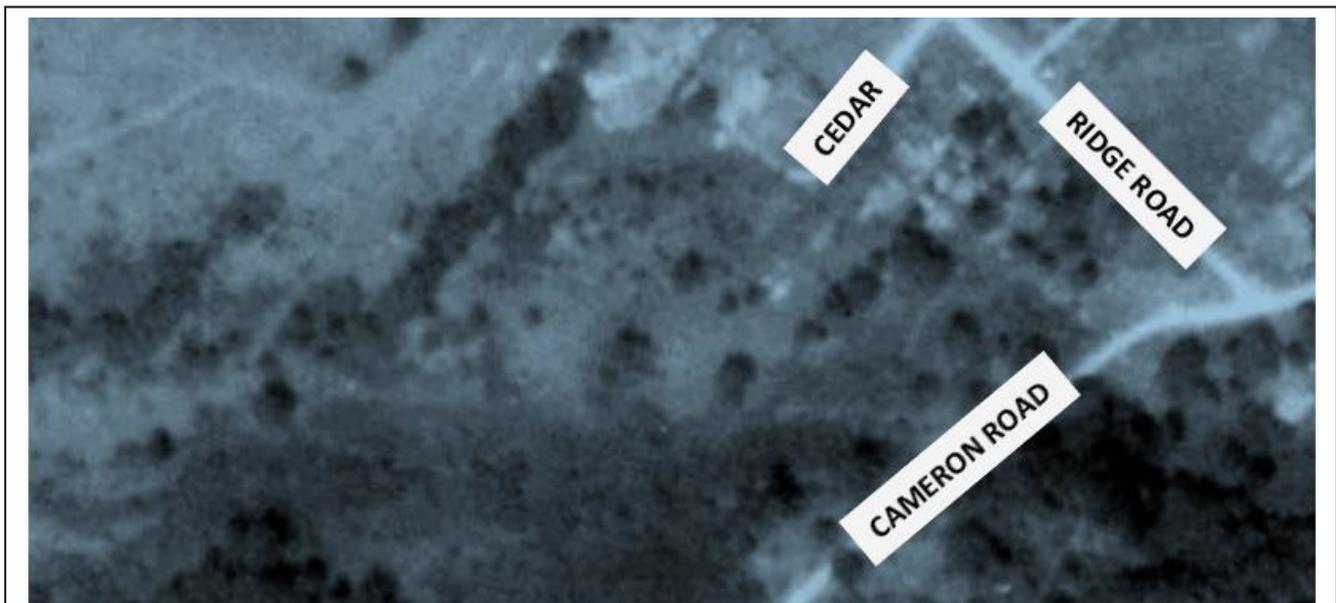
Figure 2: Air photo of the future Pine Lake basin *circa* 1944. The corner of Cameron and Ridge is at the upper right, Cedar coming south off Ridge, and Mount Pleasant Road is not yet built. The river valley before a dam was built in 1946 appears to have been either an open meadow or an alder thicket with a few isolated trees. Image courtesy of Martin Hofton.

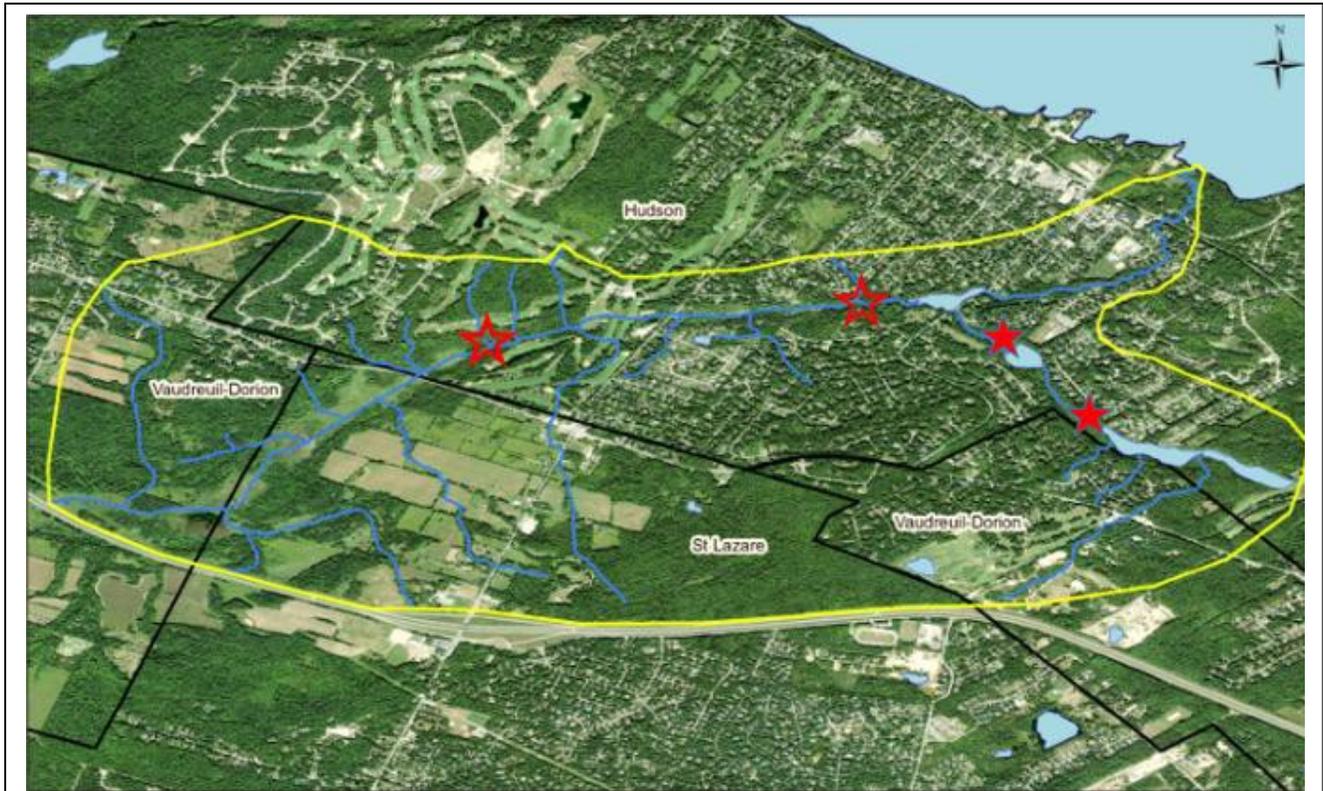
Fig 3. The Viviry River and its tributaries; the yellow line delimits the watershed – rain and snow melt within the watershed boundaries contribute significantly to flow in the Viviry River. Tributaries flowing north into the Viviry are fed by a combination of surface runoff plus a significant amount of groundwater leaking from the St-Lazare Plateau, a shallow aquifer under the subwash fan deposited during the retreat of the Laurentide Ice Sheet ~9500 years ago. Groundwater in the St-Lazare Plateau mostly originates as rain and snow melt outside the Viviry River watershed. A similar combination of runoff and groundwater sources prevails in south-flowing tributaries originating on the Hudson Highlands, which are another subwash fan laid down by the melting ice sheet. Well-water drawn from these shallow aquifers will reduce flows into the Viviry River as future development increases water use. The solid red stars indicate positions of existing check dams that provide some flood control along the Black Creek tributary; open red stars indicate sites of old beaver dams that could be rebuilt into check dams along the main river channel.

9. Building of check dams could help reduce sediment loading into the dredged lake basin and improve flood control, in the immediate future or over time. Two upstream sites are suitable for construction of check dams, both previously dammed by beavers (*cf.* Fig 3). Construction of check dams would require ministry approval, although beavers need no approval so we might just encourage them to do the job at no cost to the town.

6. Building of check dams could help reduce sediment loading into the dredged lake basin and improve flood control, in the immediate future or over time. Two upstream sites are suitable for construction of check dams, both previously dammed by beavers (cf. Fig 3). Construction of check dams would require ministry approval, although beavers need no approval so we might just wait for them to do the job at no cost to the town.

5. Building check dams upstream also could help reduce sediment loading into the dredged lake basin and improve flood control, in the immediate future or over time. Two upstream sites are suitable for construction of check dams, both previously dammed by beavers (cf. Fig 3). Construction of check dams would require ministry approval, although beavers need no approval so we might just wait for them to do the job at no cost to the town.

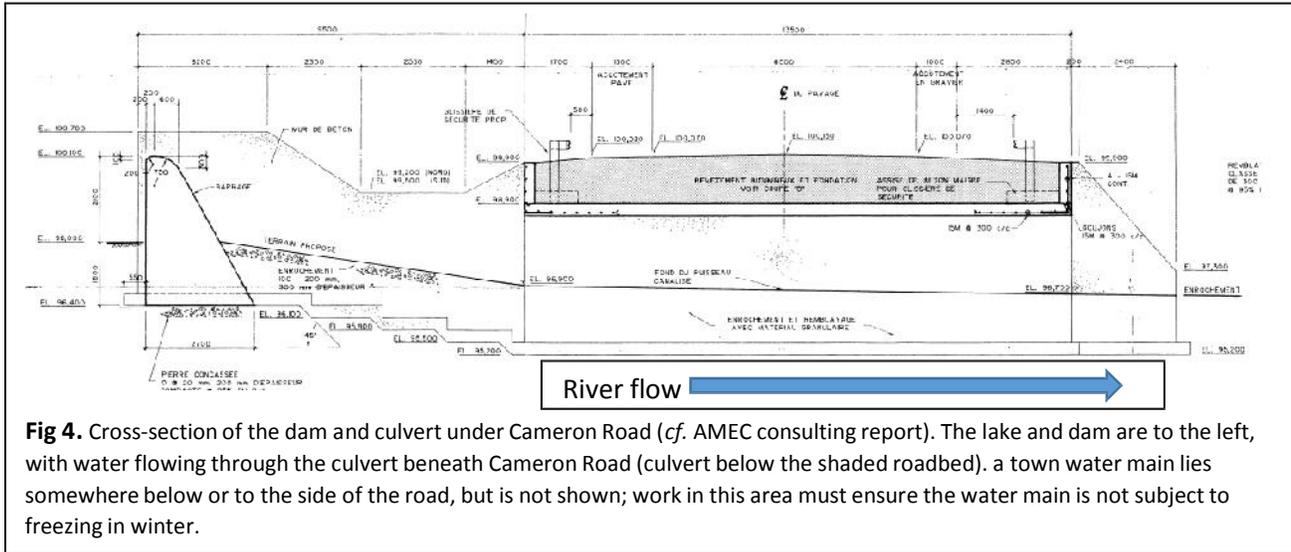
Fig 4. Cross-section of the dam and culvert under Cameron Road (cf. AMEC consulting report). The lake and dam are to the left, with water flowing through the culvert beneath Cameron Road (culvert below the shaded roadbed). a town water main lies somewhere below or to the side of the road, but is not shown; work in this area must ensure the water main is not subject to freezing in winter.

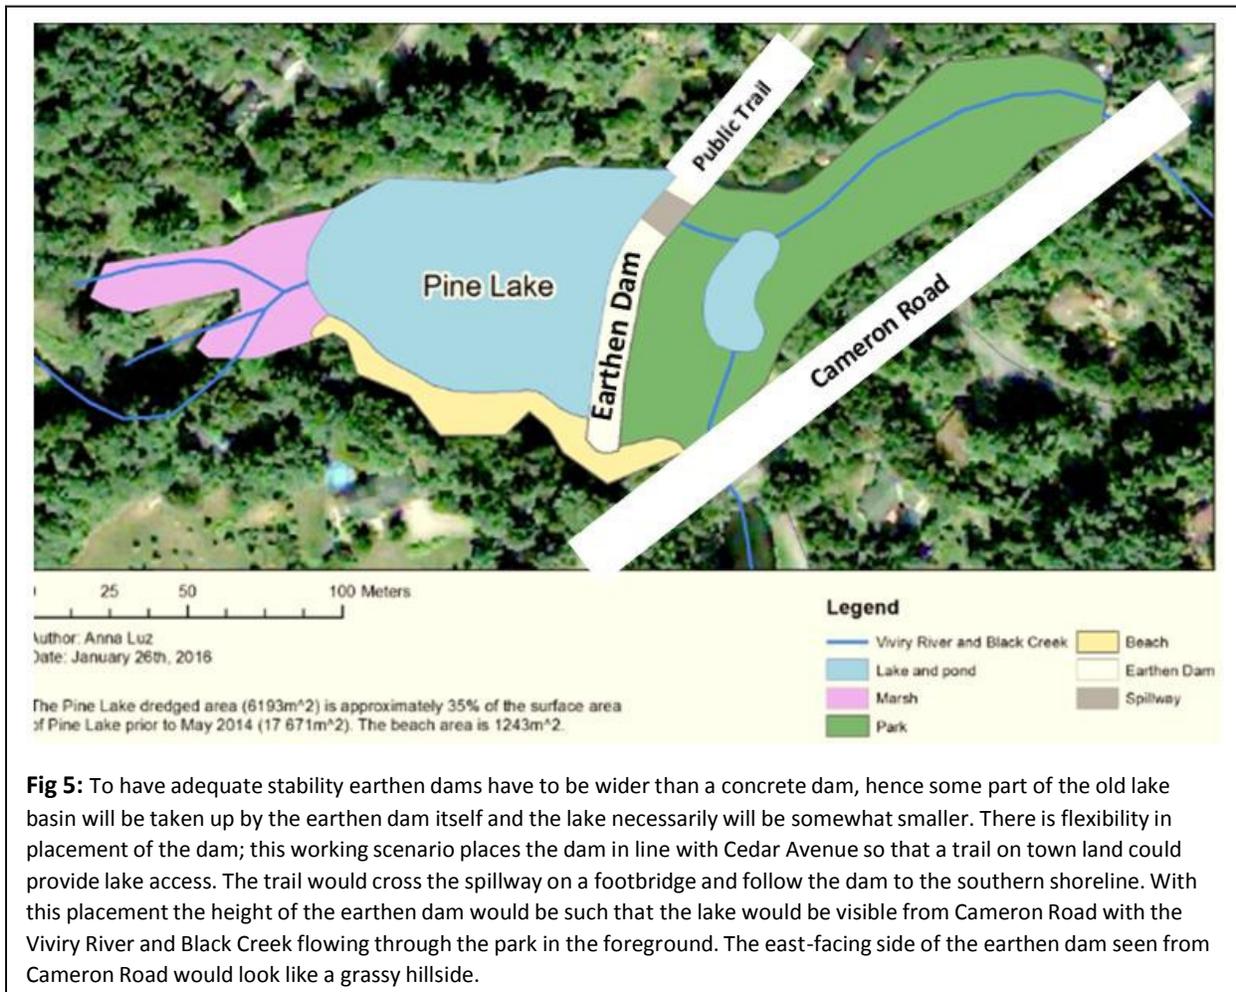
Fig 5: To have adequate stability earthen dams have to be wider than a concrete dam, hence some part of the old lake basin will be taken up by the earthen dam itself and the lake necessarily will be somewhat smaller. There is flexibility in placement of the dam; this working scenario places the dam in line with Cedar Avenue so that a trail on town land could provide lake access. The trail would cross the spillway on a footbridge and follow the dam to the southern shoreline. With this placement the height of the earthen dam would be such that the lake would be visible from Cameron Road with the Viviry River and Black Creek flowing through the park in the foreground. The east-facing side of the earthen dam seen from Cameron Road would look like a grassy hillside.

In the present scenario we move the earthen dam upstream (cf. Fig 5), dredge a deeper but smaller lake basin, and use the spoils to construct the earthen dam as well as an accessible southern shoreline and parking spaces along Cameron Road. By adding a bridge over the spillway, the top of the earthen dam could serve as a walkway connecting to a public trail on existing town land at the end of Cedar Avenue. In this design the area below the earthen dam would be either a meadow or public park with Black Creek running through it as an open stream, perhaps with a small pond or marsh at some point. The Viviry River would provide a natural barrier between the park and adjacent private properties; the spillway could be built as a

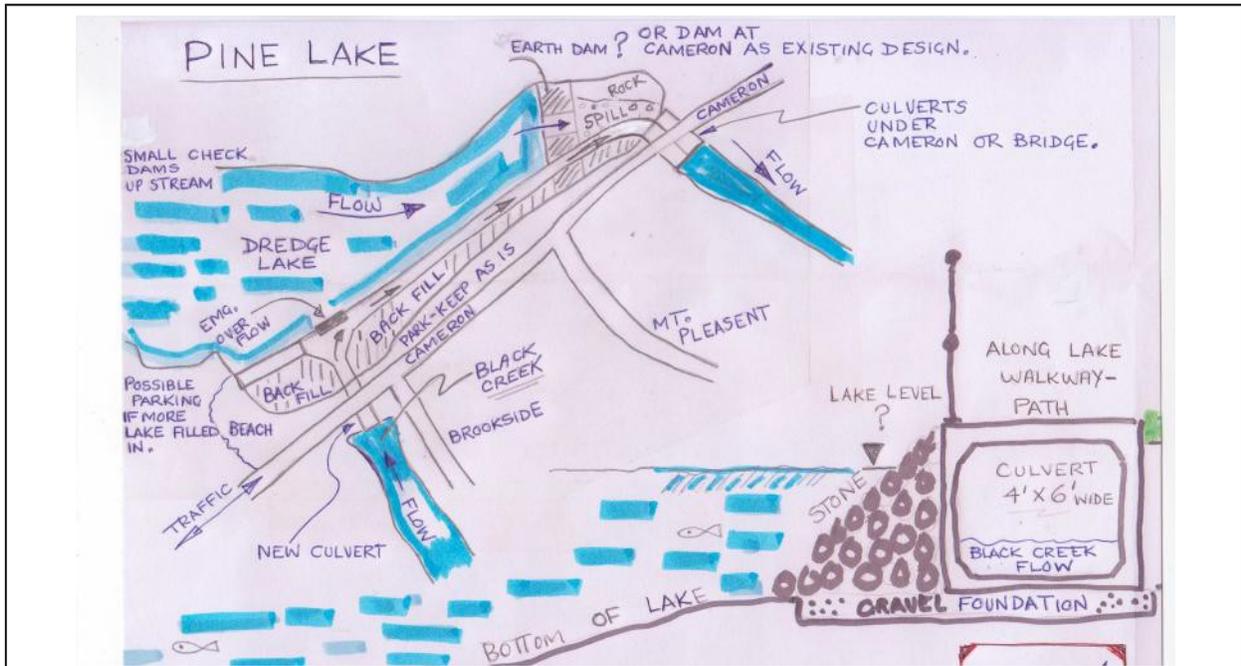
Fig 6: Diversion of Black Creek to enter the Viviry River downstream from the dam showing the route of the diversion and a cross-section of the covered culverts that would carry the flow underground between the lake shore and Cameron Road. Drawing by Ken Walker.

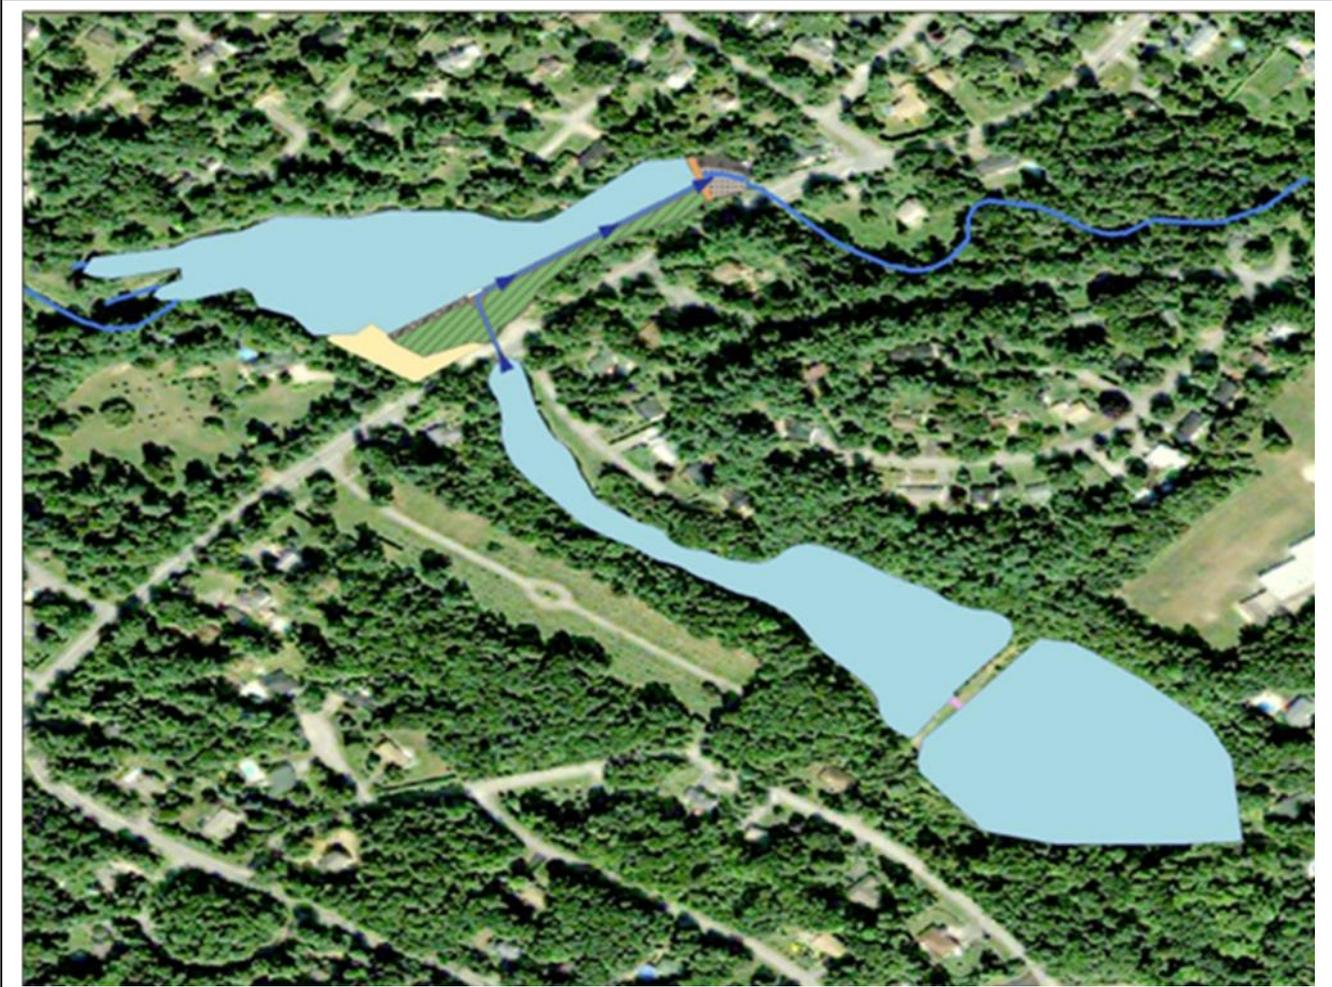
Figure 8b. The lower reach of Black Creek as an auxiliary retention basin. During major floods the town could open the overflow gate in the side of the Black Creek culvert to let water drain from the lake to reduce the risk of the dam failing. Lake water would then flow through the Black Creek culvert into the Viviry below the dam and also spill upstream in Black Creek to flood the marshy areas associated with the Driscoll-Naylor Bird Sanctuary. Periodic flooding would be advantageous to the marsh vegetation and provide temporary flood retention capacity without risk to residential properties.

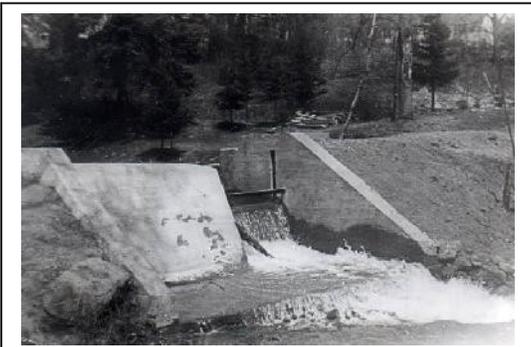
#1 Spillway of the original earthen dam as it was in 1947. Cameron Rd at this time was below its present grade. The lake was held back behind an earthen dam (berm) along Cameron Rd. (MH)

EXP did not specifically show the placement or design of their earthen dam, which could take many forms. One possible design essentially replicates the original dam built in 1946 (c.f. photos #1 and #2 in Appendix 1): an earthen dam parallel to Cameron Road. The 1946 dam had a concrete spillway at the site of the 1990 dam, with the lake water level controlled simply by insertion of barriers into slots in the spillway walls. This design requires the sill of the spillway to be below the present level of Cameron Road at the Black Creek culvert, which we believe unduly restricts the possibility of optimizing the design of an earthen dam relative to present and future flood risks. We subsequently present scenario 6 as a variant on this alternative that secures greater flood control by diverting the flow of Black Creek.

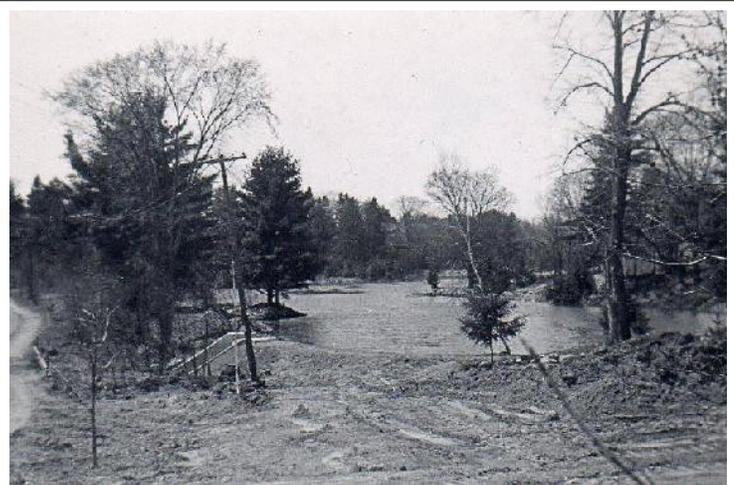
#2 Pine Lake in 1947 – Unpaved Cameron Rd to the far left is below present grade, and the earthen dam to the right of the spillway clearly visible. Cynthia Maher’s property not yet developed at this time. (MH)

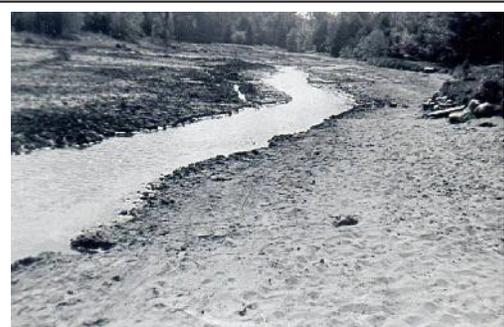
#3 Pine Lake was drained in 1957 to dredge a 60 x 200 foot ‘swimming hole’, 10 feet deep, and about 40 feet off the beach along Cameron Road. (MH)

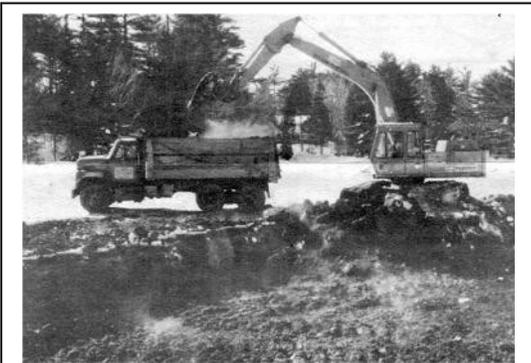
#5 The lake bed was dredged in winter 1987, three years after the town took responsibility for Pine Lake. In 1984 it had been estimated that 15,000 yards³ of sediment needed to be removed. (MH)

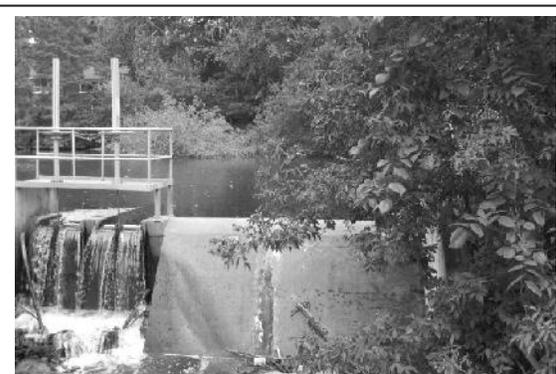
#6 The Pine Lake dam just after it was rebuilt in 1990; this is the dam that failed in April 2014. (MH)
